## TE-DGH/TE-DGHC (CMOS)

**RAM 1500 (2009-2017)  
RAM 2500 (2010-2017)**

### Replacement Tailgate Handle with Camera

#### Removal and Installation Instructions

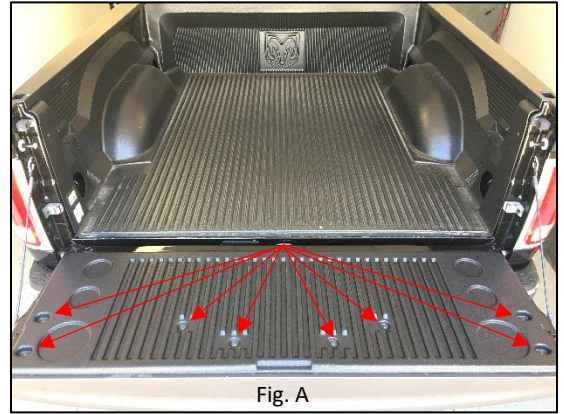
1. Start by lowering the tailgate and remove the (8) T30 torx screws from the bed liner, remove liner (Fig. A), remove access panel (Fig. B), and place aside.
2. Now that you have access to the handle assembly, disconnect harness running to lock actuator and unclip (2) latch rods. (Fig. C)
3. Next, remove (2) 8mm nuts located below latch connectors, then slide latch assembly aside. (Fig. C)
4. Gently remove handle by lifting the handle from the outside and slowly working it out.
5. Now that the handle is out of the tailgate, you will have to swap the locking mechanism out of the old handle to the new one.
6. Start by removing the (2) 8mm screws from locking mechanism, and then remove mechanism from handle. (Fig. D)
7. Now place the locking mechanism in the new handle and secure it with the factory 8mm screws.

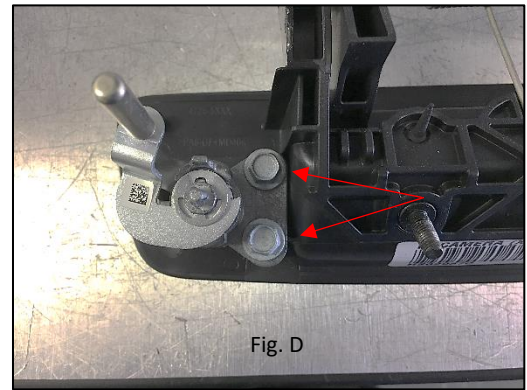
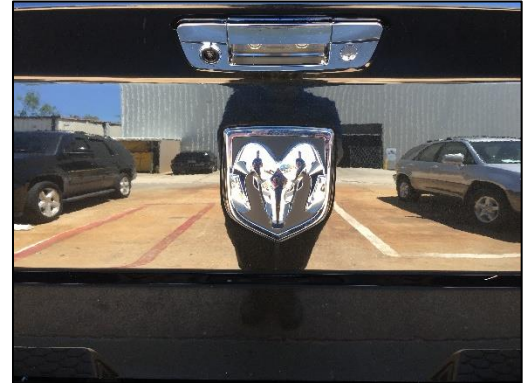
10. Now gently reinsert new tailgate handle and route cable trough tailgate.

11. Realign the handle's post with latch assembly opening mechanism and reattach 8mm nuts to secure handle in tailgate.
12. Reconnect harness to lock actuator and reattach latch rods, then reattach the tailgate's access panel and bed liner cover to complete your install.
